CONTINUING PUBLIC HEALTH, SAFETY, AND ENVIRONMENTAL THREATS FROM THE ATLANTIC COAST PIPELINE PIPE COATING

WILLIAM F. LIMPERT

JUNE 29, 2020

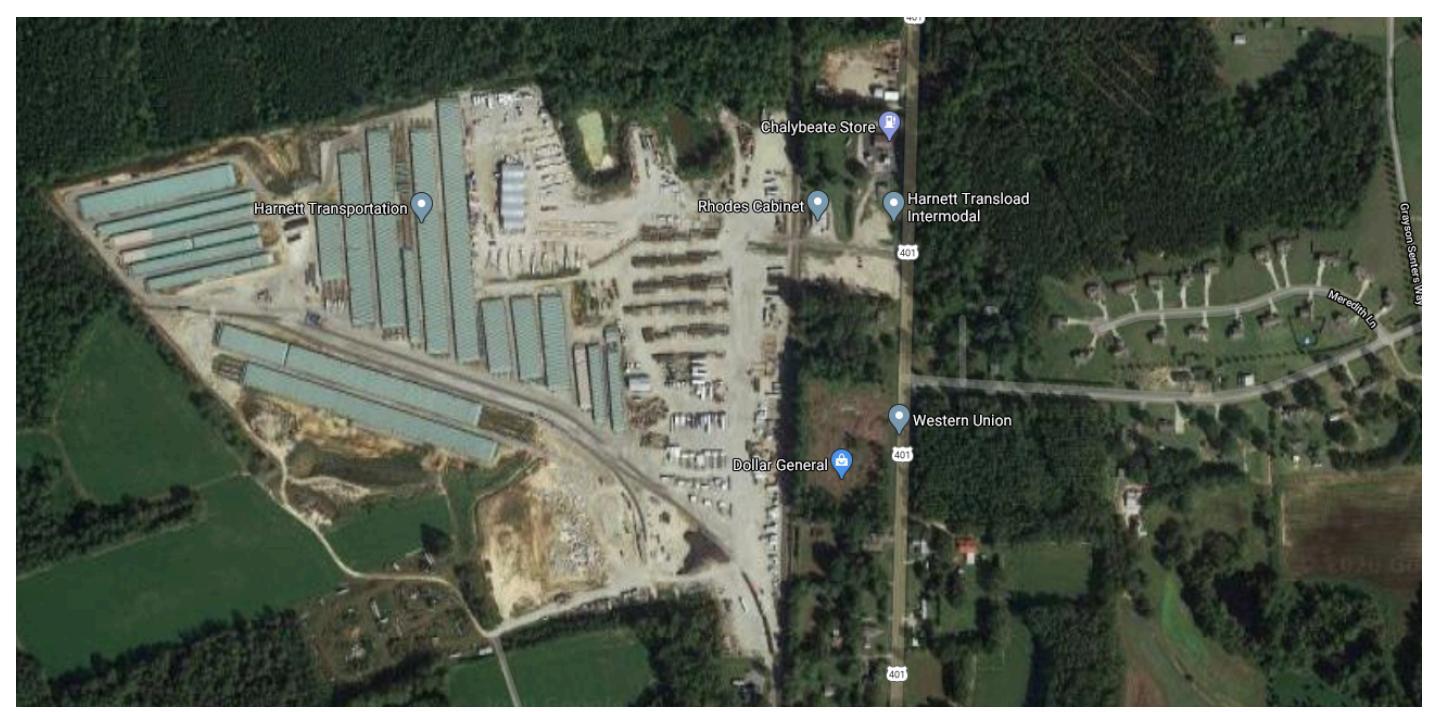
Dominion Energy and Duke Energy are storing acres of pipe in open sunlight at sites in six communities, close to homes and public buildings. This storage yard is in Fuquay Varina, N.C. (Google Earth)

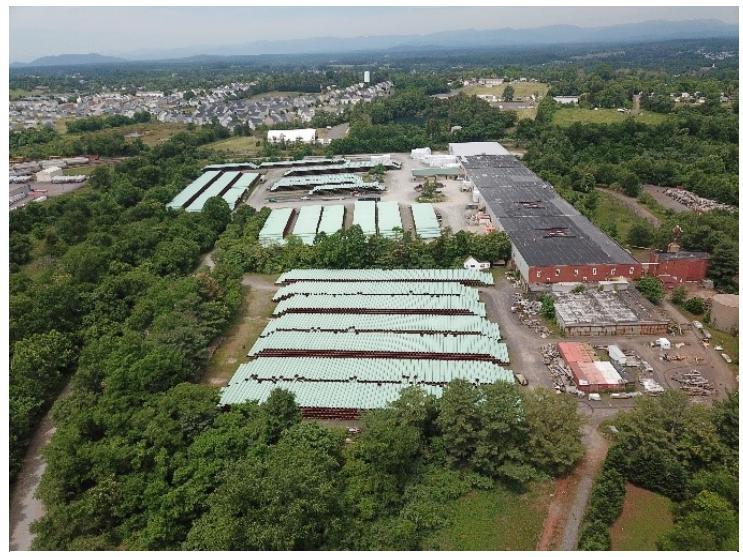
Acres of ACP pipe in a storage yard just outside of Culpeper, VA. (Allegheny-Blue Ridge Alliance)

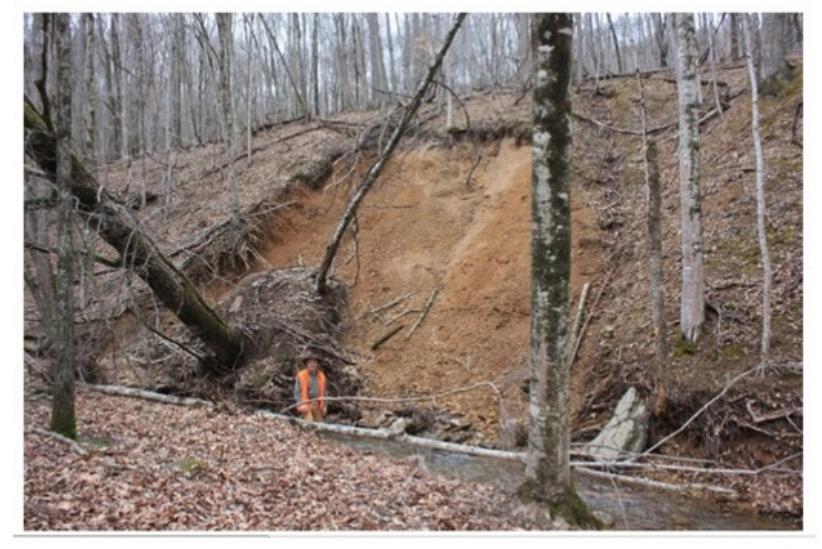
Duke Energy and Dominion Energy chose a route prone to landslides, which increases the risk of a high-pressure gas leak and explosion – especially when the pipe's anti-corrosion coating is degraded. Several landslides occurred on the author's property and in Virginia's Little Valley in 2015 during a four-inch rain event, all within several hundred feet of the proposed ACP. Duke and Dominion's consultant claimed the largest of these landslides was only a minor hazard, without ever inspecting the slide. (William Limpert)
